INFRARED MOISTURE SURVEY REPORT

ANDREW SUDA
HIGH RIDGE, MO
(314) 805-5820

Maryland Heights, MO 63146

Inspection Date:	07/22/2021	
Report Date:	07/23/2021	
Job Number:	21-0701	
Type of Inspection:	Roof IR Inspection	
Purpose of Inspection:	Inspect Roof for Suspected Internal Moisture Content	
End User:	Andrew Suda - Midwest Aerial Services	
Project Location:	<div style="background-color: black; width: 100px; height: 1.2em; margin-bottom: 5px;"></div> Maryland Heights, MO 63146	
Thermographer:	Andrew Suda	
Certificate Number:	249858	
Certification Level:	Level I Thermographer	
Qualified Assistant:	Olson Roofing Systems	
Equipment Used:	Flir Vue Pro 336 13mm	
Weather Data:	Day Skies: Clear AM: 76 F (0800 CST) Night Skies: Clear	Flight Time Range: 1945 - 2040 hours Cloud Cover: 12% Temp: 85 F Wind: 5 mph NW
Last Precipitation:	07/16/2021 Rain: 1.17 in	
# Items Inspected:	37,308 sq' (TPO) Roof System	
# Thermograms:	21

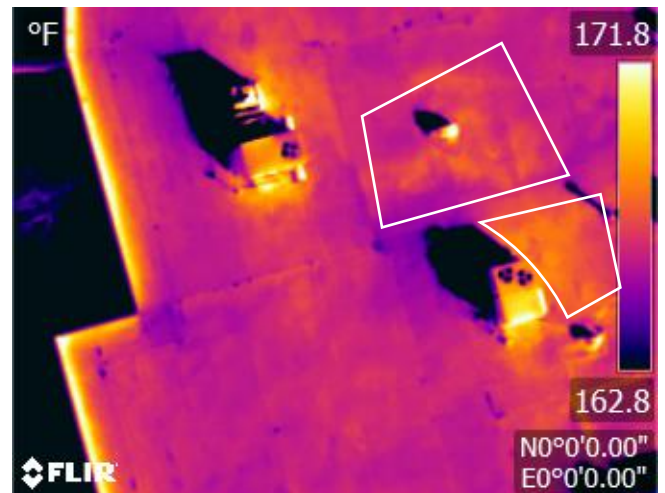
Image #: Over Head View

Apparent moisture identified with white boxes.
