INFRARED MOISTURE SURVEY REPORT

ANDREW SUDA
HIGH RIDGE, MO
(314) 805-5820

Maryland Heights, MO 63146

Inspection Date:	07/22/2021	
Report Date:	07/23/2021	
Job Number:	21-0701	
Type of Inspection:	Roof IR Inspection	
Purpose of Inspection:	Inspect Roof for Suspected Internal Moisture Content	
End User:	Andrew Suda - Midwest Aerial Services	
Project Location:	<div style="background-color: black; width: 100px; height: 1.2em; margin-bottom: 5px;"></div> Maryland Heights, MO 63146	
Thermographer:	Andrew Suda	
Certificate Number:	249858	
Certification Level:	Level I Thermographer	
Qualified Assistant:	Olson Roofing Systems	
Equipment Used:	Flir Vue Pro 336 13mm	
Weather Data:	Day Skies: Clear AM: 76 F (0800 CST) Night Skies: Clear	Flight Time Range: 1945 - 2040 hours Cloud Cover: 12% Temp: 85 F Wind: 5 mph NW
Last Precipitation:	07/16/2021 Rain: 1.17 in	
# Items Inspected:	37,308 sq' (TPO) Roof System	
# Thermograms:	21

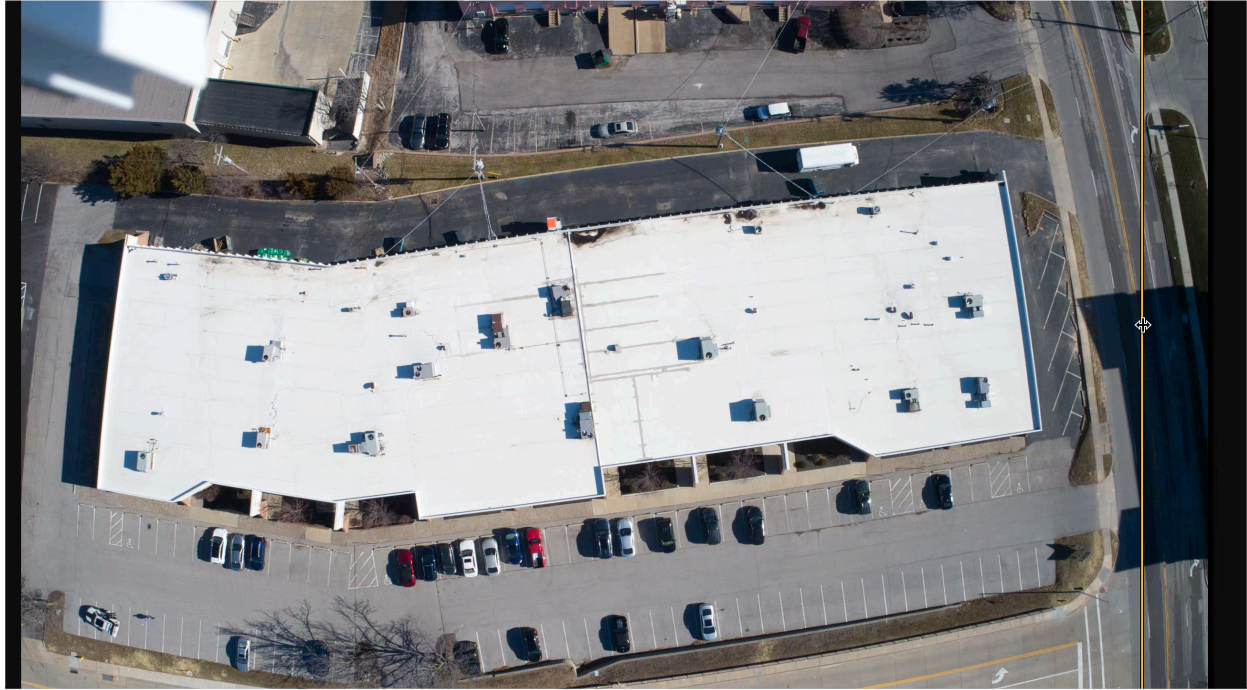
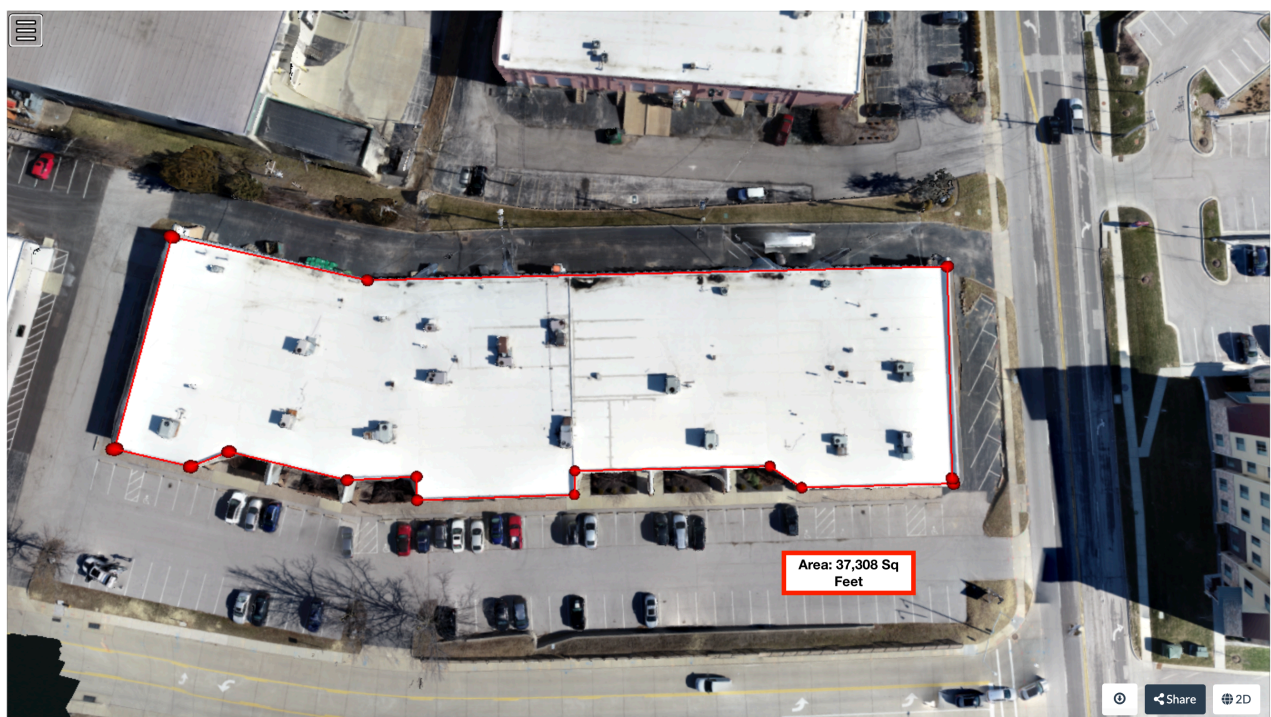
Image #: Over Head View

Apparent moisture identified with white boxes.

AI (Artificial Intelligence) Enhanced

Area: 37,308 Sq Feet
